TP 14735E

A Low-Cost Rail Warning System for Private and Farm Road Crossings

University of New Brunswick
Transportation Group

May 2007

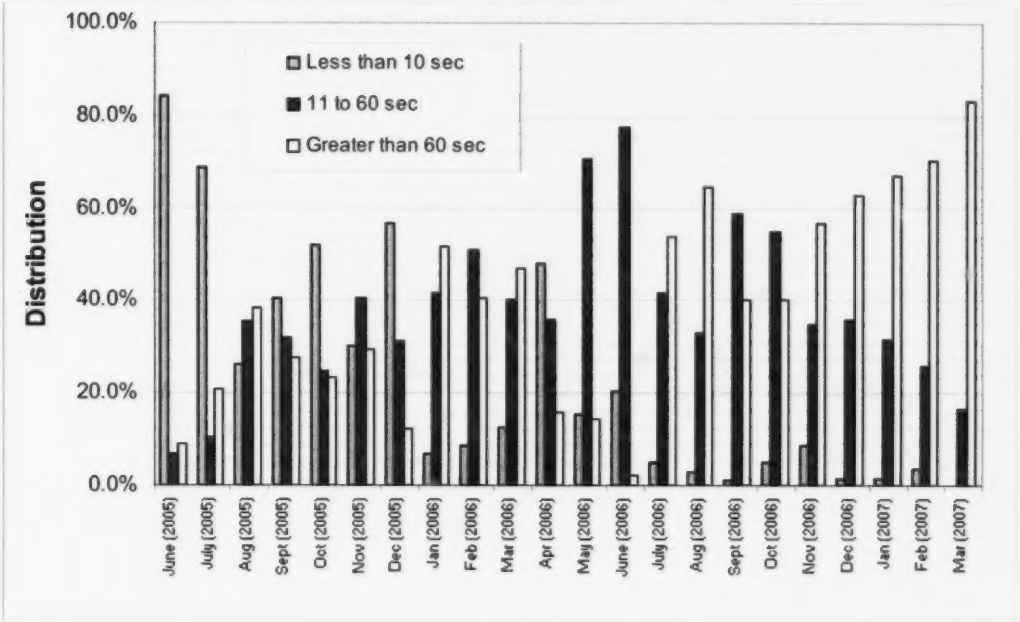
Figure 6.7 - Distribution of Activation Lengths (Seconds) by Month

As can be seen in Figure 6.7, prior to the installation of the software update in late December 2005, there were typically a greater number of smaller activations. In the months prior to the update, activations less than 10 seconds accounted for at least 20 percent of the total in each month. In June, July, October, and December 2005, activations less than 10 seconds accounted for over 50 percnet of the total. Following the December 2005 software update, these figures were much improved and the percentage of activations less than 10 seconds was below 20 percent. The percentage of activations over a minute was in excess of 40 percent for January to March 2006. Once the faulty

radar unit was replaced and properly aligned (June 2006), the data settled into a consistent pattern with relatively few short duration activations and proportionately more activations over 60 seconds.

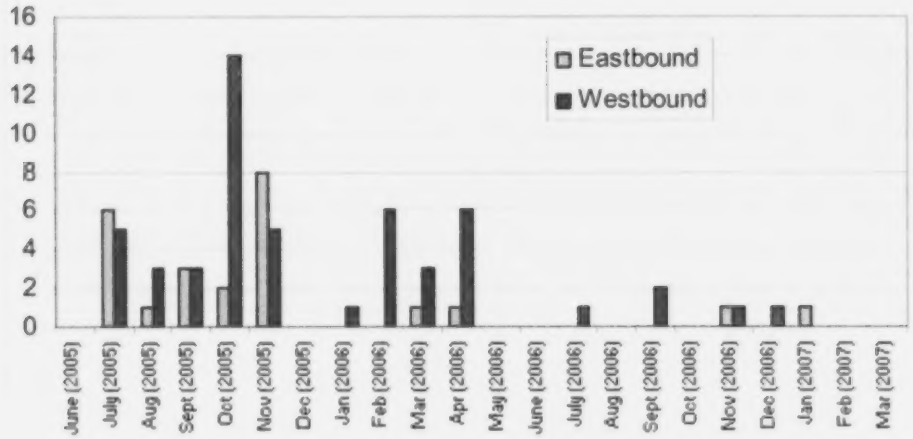
Figure 6.9- Number of Interrupted Activations by Month

Another concern that arose during testing was that of activation interruptions. Interruptions are of particular concern because it means the LED lights are no longer flashing and therefore not providing any warning of the presence of a train. On a number of occasions, the system would detect a train and would then experience an intermittent interruption in the activation before resuming. These interruptions varied in length and appeared to show no pattern in terms of when they occurred or the direction in which they occurred. The number of interrupted activations is shown in Figure 6.9, while Figure 6.10 shows the average length of interruption by month and train direction.

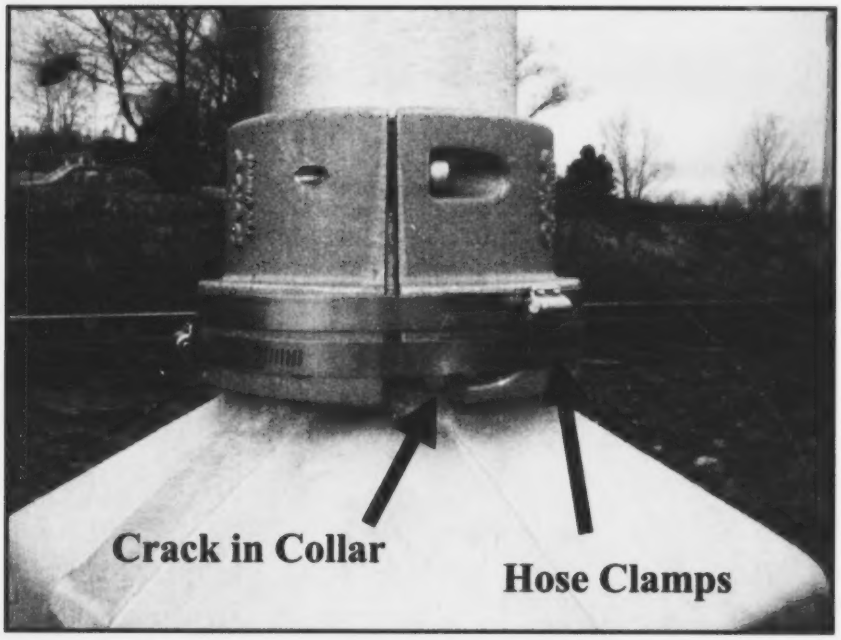
Figure 6.11 - Crack in Collar and Hose Clamps to Secure Base in Place

Another problem arose with respect to the base holding the pole in place. The aluminum base was attached to a concrete pad with leg bolts and the pole rested within a three-inch sleeve in the base, fixed in place by a pre-cast aluminum collar. On January 19, 2006, a combination of high winds and the large area of solar panel being supported by the pole caused the collar to crack; consequently, the pole leaned heavily to one side. The pole was righted and hose clamps were used to hold the collar in place (Figure 6.11). This same scenario was repeated two or three times in the following week, at which time it was decided that the base was inadequate and needed to be replaced. The over-sized solar panel was a contributing factor in this failure.

On January 31, 2006, a replacement base was installed. The new base, as seen in Figure 6.12, was a much more rigid design that allowed for the insertion of approximately 12 inches of the pole into the base.
